MOISTURE ENTRAPMENT IN BUILDINGS WITH EIFS AND STUCCO FACADES IN THE STATE OF FLORIDA

BY KATHRYN M. BARKER AND MICHAEL G. KNETTEL

This paper presents thermographic examples of case studies performed by the authors on Exterior Insulation and Finish Systems (EIFS) and stucco veneer buildings within the state of Florida and is presented to raise awareness of damage that can occur when EIFS or stucco systems fail.

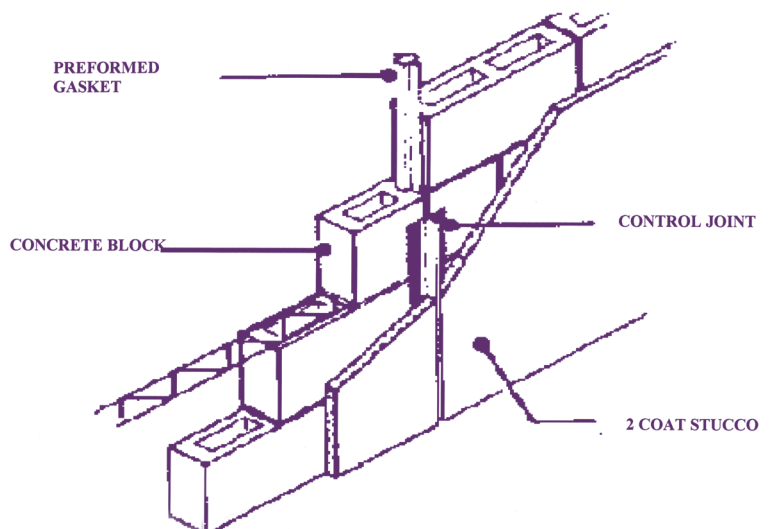
Figure 7: Rough drawing of the wall mechanism demonstrated in figures 8-11.

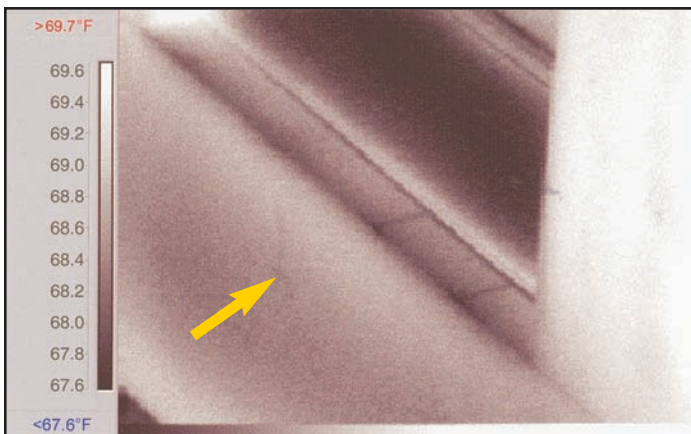
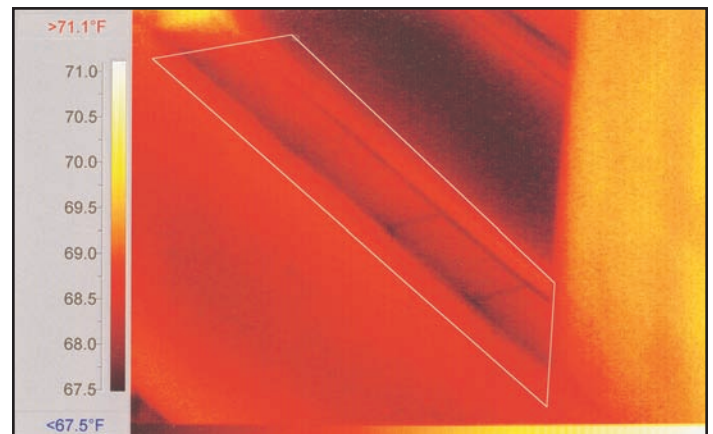
Figures 13 (left) and 14 (right) are thermograms of water intrusion at a window ledge. Moisture intrusion was caused by lack of caulking and caulking bond failure.
