EPDM —

Solution to Airport Roof Problems

By Nick A. Lovato

Figure 1: Denver International Airport.

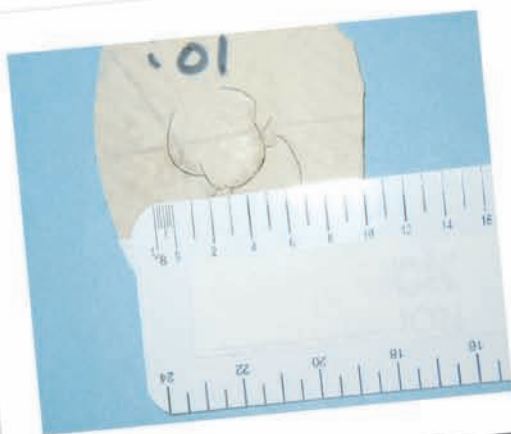
Figure 2:
Hail-damaged membrane.

The damage noted was more extensive on the darker discolored sheets used to construct the PVC membrane, (which apparently had different run numbers), and in areas that were exposed to more solar radiation. New cracks developed in the membrane at hail impacts that were not noticeable during the first visual inspection. The visible cracks were repaired immediately with EPDM primer and EPDM peel-and-stick flashing tape. The repairs were paint-

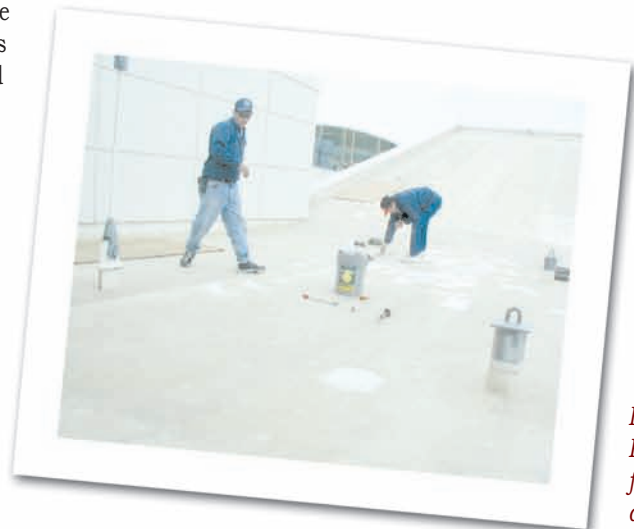
Figure 3:
Patches from hail damage.

ed white to prevent thermal degradation of the polystyrene insulation below.

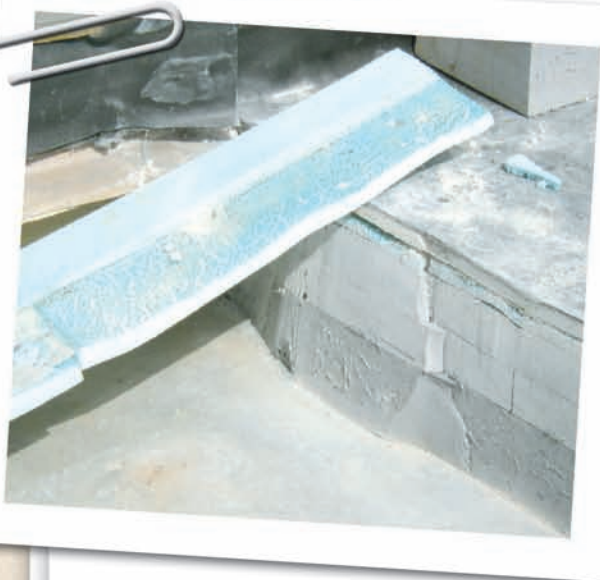
Figure 4: Melted XEPS.

extruded polystyrene rigid insulation boards had melted or deformed from heat, particularly where the slip sheet was damaged or missing, and in areas next to the reflective clerestory windows (refer to *Figure 1* for view of window areas). To melt extruded polystyrene, the temperature needs to reach 165°F or greater, according to the manufacturer's published literature.

exceeded the air temperature by 60°F to 70°F, which is incongruous with static thermo profiles of building envelopes that have been presented in the past. The slip sheet protected the polystyrene somewhat, but did not prevent deformation of the insulation board. Insulation boards that were severely deformed or melted were replaced with like kind.

A single layer of 5/8" glass-faced gypsum board with a primed surface was installed over the existing polystyrene rigid insulation (secured with mechanical fasteners and Galvalume™ metal plates) to provide a dense, hail-resistant substrate for the new membrane and divorce the polystyrene from the elevated temperatures that were anticipated with the new black EPDM membrane. A couple of isolated areas, near clerestory reflective windows, experienced some heat degradation and had to be repaired (*Figure 4*).

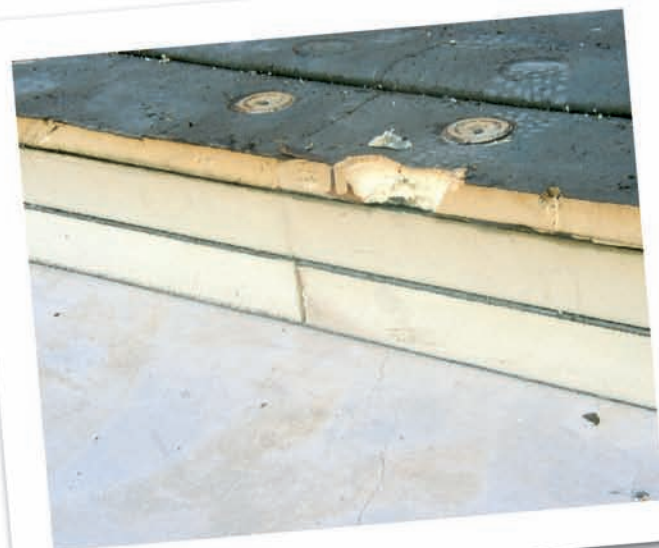
Figure 5:
Damaged oxidized polyisocyanurate.

On the concrete deck areas, several problems (moderate to severe) were noted that were not evident on the metal deck areas. The organic facer was deteriorated, the membrane was delaminated from the facer, the insulation board was buckled in a convex fashion, the top 1/4" layer of the board was discolored and friable, the insulation fasteners and plates were corroded, and the glued EPDM seams were delaminated (refer to Figure 5). Each one of these problems can be attributed to the effects of moisture. Residual water from the poured-in-place concrete was the probable source of the initial moisture, causing the EPDM seams to fail within a relatively short time, which precipitated the damage to the insulation board and fasteners. More water entered the roof system via open seams, which exacerbated the deleterious effects of moisture on the roofing components. There was evidence that patches and repairs were made when leaks occurred, but the residual moisture was probably not removed.

On the airport project, evidence shows that the permeability of the EPDM membrane was not sufficient to allow adequate amounts of water vapor to escape to the atmosphere. The polyisocyanurate rigid insulation and facer at the DIA project experienced numerous cycles of wetting and drying as a result of the residual moisture trapped between the deck and black EPDM membrane. The black membrane reached temperatures of 180°F in the summer, which increased the thermal gradient, vapor pressure, and therefore, the vapor diffusion rate, thereby accelerating the degradation of the foam insulation and facer on the top side of the boards. This, however,

would not explain the brown discoloration of the top surface of the insulation board (refer to *Figure 5*), which is usually indicative of photochemical oxidation. The solvents in the bonding adhesive, in concert with moisture and heat, may have reacted with the polymer matrix of the insulation board. Further study is needed. This demonstrates the need for a vapor retarder over freshly-poured (moisture-laden) concrete decks.
