CONCRETE SLAB-ON-GRADE MOISTURE TESTS:

HOW USEFUL ARE THE TESTING DATA WHEN THE VAPOR BARRIER MAY BE INEFFECTIVE?

By Lonnie Haughton, CDT, LEED AP

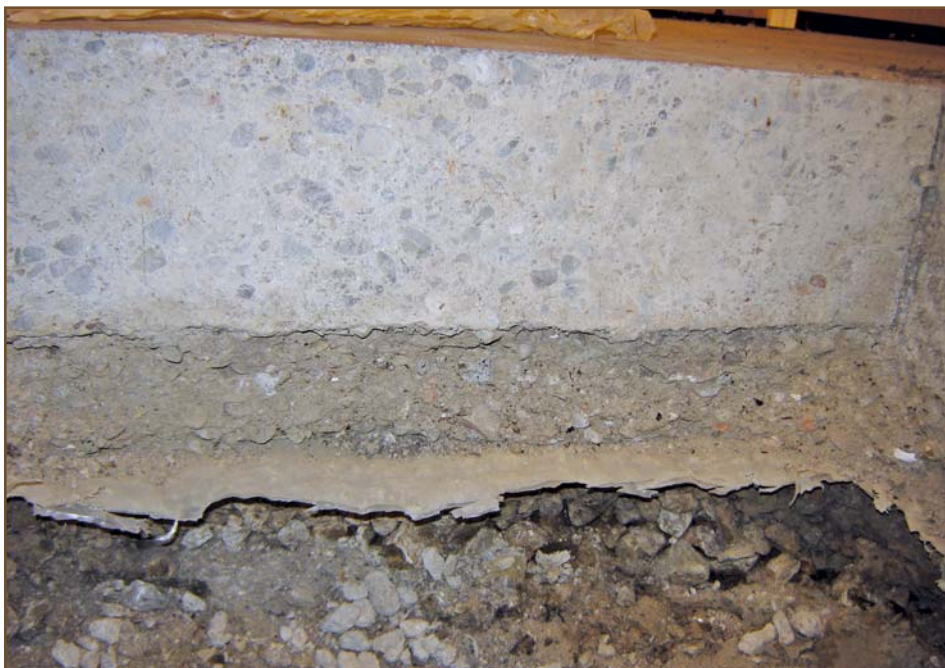
Photo 1 – Test cut at concrete slab reveals compacted granular fill above the plastic vapor barrier and the granular drainage base.

Therefore, let’s consider a test cut (see *Photo 1*) of the concrete slab at the noncarpeted storage room. We find a 6-in concrete slab over a 3-in layer of compacted granular fill over two layers of 10-mil polyethylene over a layer of drainage material. Our first observation is that the concrete slab has not been placed directly upon the plastic vapor barrier. The authors of ACI 302.2R-06 warn us that this simple design decision, in and of itself, is sufficient to prevent us from trusting the results of our moisture testing as a predictor of successful long-term flooring performance:

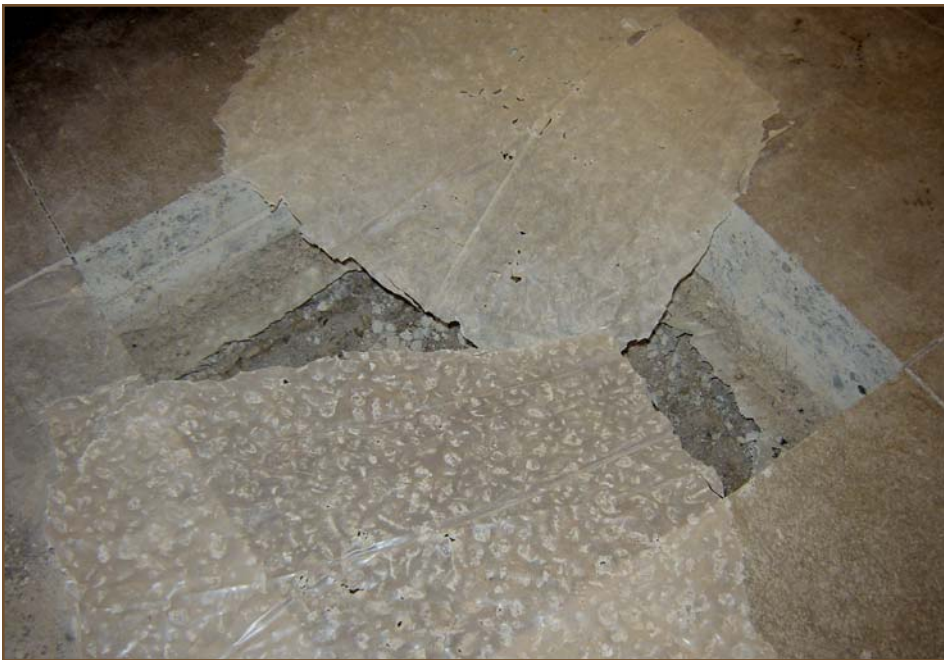
Photo 2 – Polyethylene sheeting has numerous punctures, thus negating its usefulness as a vapor barrier.

Further, as seen in *Photo 2*, numerous punctures in the polyethylene sheeting

have destroyed its usefulness as a vapor barrier, thus fully negating the predictive capabilities of our moisture-testing data:

Acceptance limits for surface moisture tests, such as the calcium chloride test, are established based on the assumption that a vapor barrier/retarder is present.

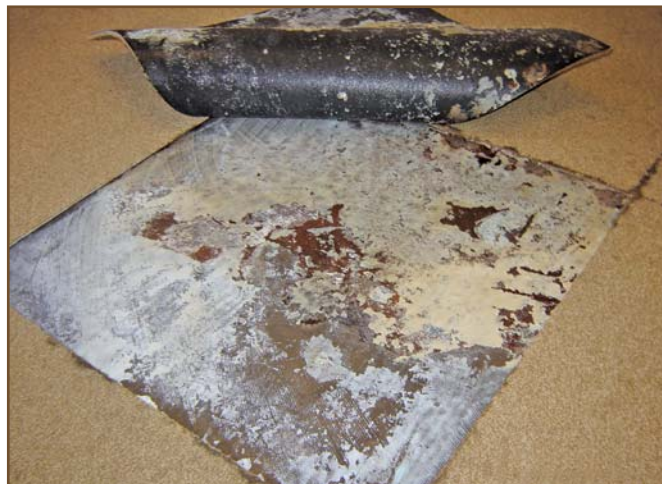
Photo 3 – Excess moisture has emulsified and deteriorated the water-soluble latex adhesives.

accompanying photographs taken at the carpeted offices adjacent to the storage areas. As seen in Photos 3 through 7, exceedingly high moisture levels at the concrete floor resulted in failure and deterioration of the water-soluble adhesive used at the rubber-backed carpet tiles.

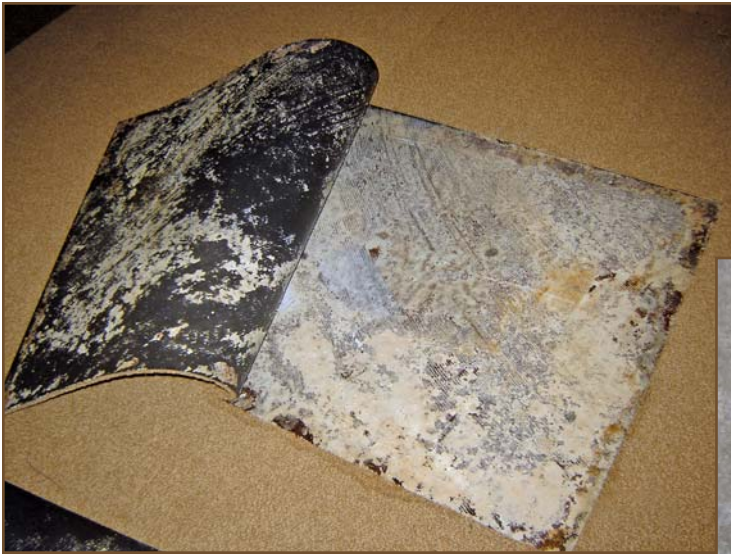
Photo 4 – Excess moisture has emulsified and deteriorated the water-soluble latex adhesives.

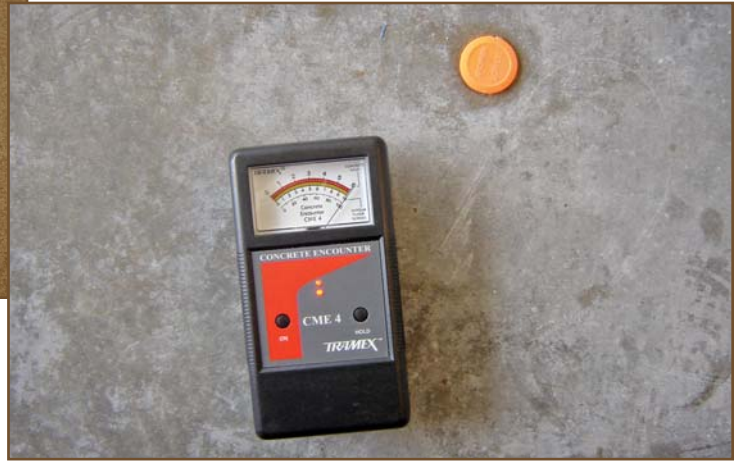
Photo 5 – At all carpeted areas, the metered MC of the concrete surface exceeds 6.0%. (The orange cap covers an internal RH sensor, per ASTM F2170.)

After reviewing these photographs, *Interface* readers and the authors of ACI 302.2R-06 will not be surprised to learn that calcium chloride testing carried out at the carpeted offices revealed very high rates of moisture-vapor emissions from the concrete slab. Similarly, internal RH sensors (see Photo 5) installed at these carpeted locations registered 99% RH, i.e., near-saturation conditions.

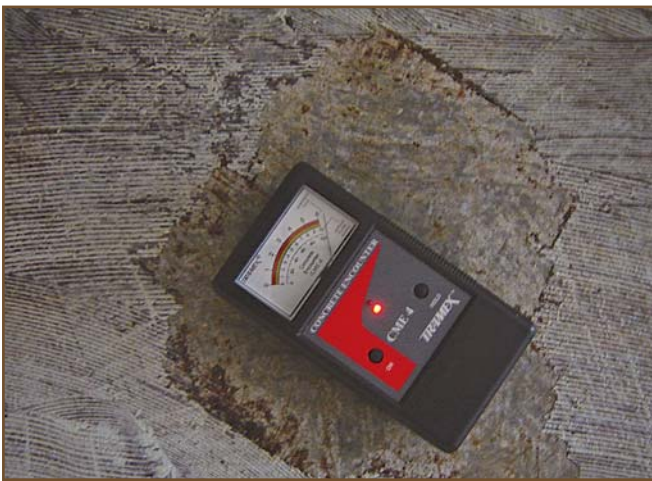
Photo 6 – At all carpeted areas, the metered MC of the concrete surface exceeds 6.0%.

Compare Photo 8, taken at one of the storage rooms, with Photos 5 and 6. We see that the MC of the noncarpeted portions of the concrete slab also is unusually high, albeit significantly lower than at the adja-

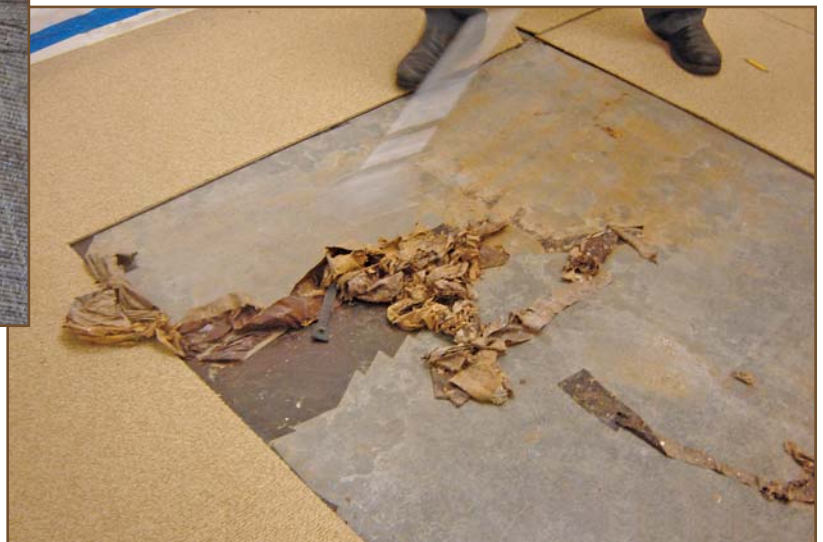
Photo 7 – Most of the failed adhesive is easily scraped from the wet concrete slab.

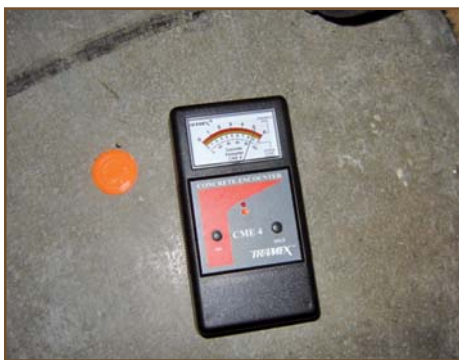
Photo 8 – At all noncarpeted areas, the metered MC of the concrete surface exceeds 5.0%. (The orange cap covers an internal RH sensor per ASTM F2170.)

Now, let’s assume that calcium chloride testing at the noncarpeted storage spaces has produced MVER results⁴ that would be deemed acceptable by floor-covering manufacturers (reference the above discussion of MVER quoted from Craig’s article in *Interface*). Further, an internal RH sensor installed into the concrete slab at a noncarpeted room (see *Photo 8*) registers only 72% RH, a value that may be acceptable to Craig and Rourke:

cent offices. If we had not already learned of the nearby flooring failure, this electrical-impedance test would have alerted us to a potential problem not identified by the calcium chloride and internal RH tests. Note that the authors of ACI 302.2R-06 advise, "More than one moisture test method may be needed to accurately determine the moisture-related suitability of a concrete subfloor, along with a thorough understanding of the slab design system."
