EPDM —

Solution to Airport Roof Problems

By Nick A. Lovato

Figure 1: Denver International Airport.

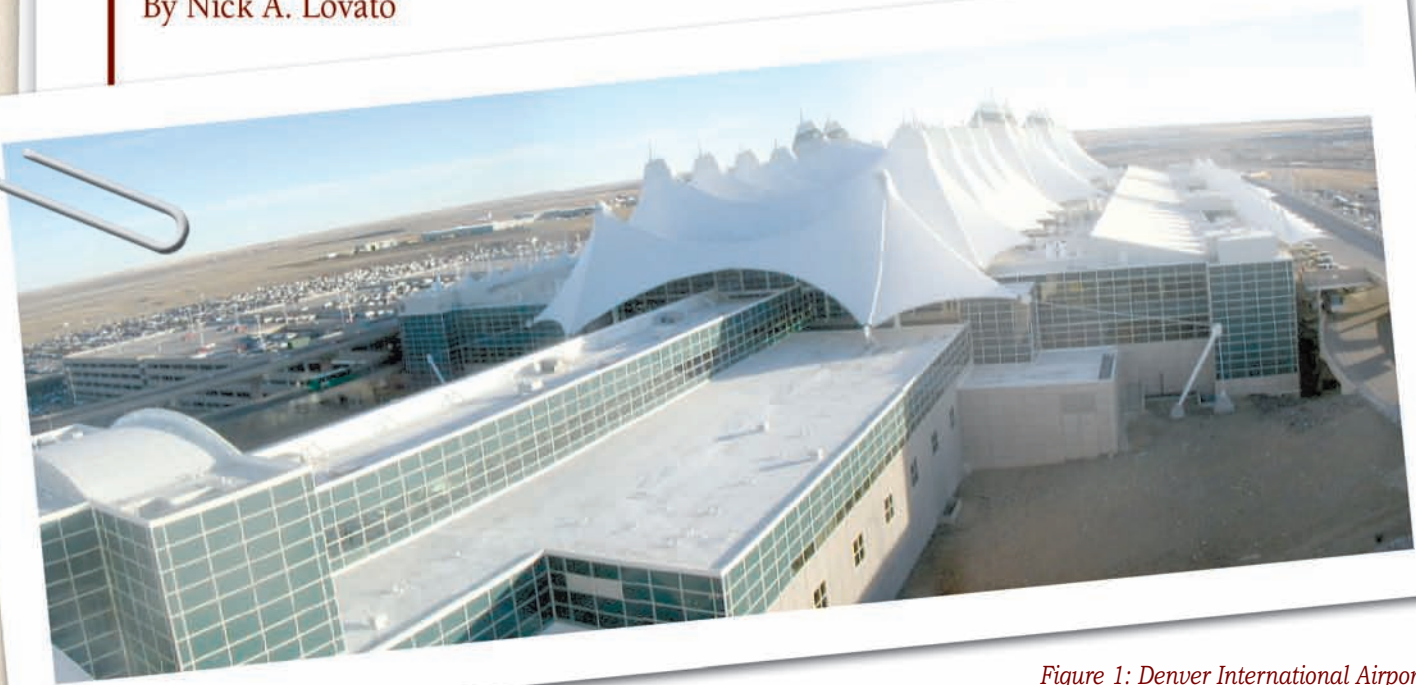
extruded polystyrene rigid insulation boards had melted or deformed from heat, particularly where the slip sheet was damaged or missing, and in areas next to the reflective clerestory windows (refer to *Figure 1* for view of window areas). To melt extruded polystyrene, the temperature needs to reach 165°F or greater, according to the manufacturer's published literature.

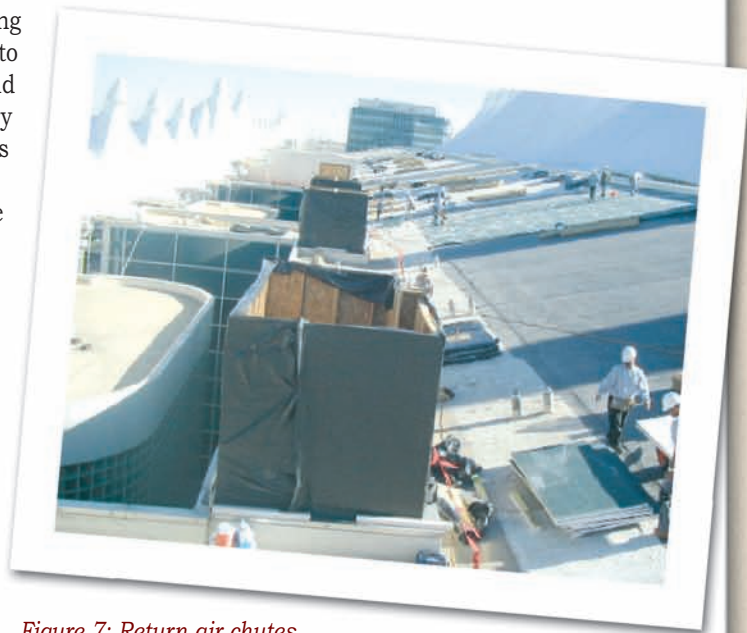
Figure 7: Return air chutes.

Return air intakes were located near the roof level, which presented a potential problem with offensive solvent fumes being drawn into the air handling units and dispersing them into the occupied building. Plywood chutes were constructed around the intakes and anchored with tie-backs to resist wind pressures. This precaution was deemed effective, and no complaints were received with regard to the solvent fumes (refer to *Figure 7*).
